# Manhole Inspection Summary

Manhole # **S13GG1005MH**

Insp Date: **6/21/07 11:49 AM**

**Location** Address: **4240 REISTERSTOWN RD** Cross Street: **CLASSEN AVE**

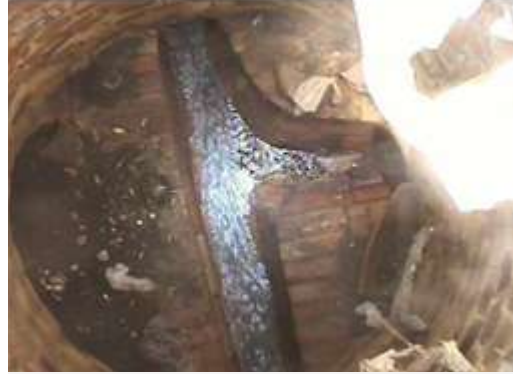
Top View

DEBRIS ON BENCH

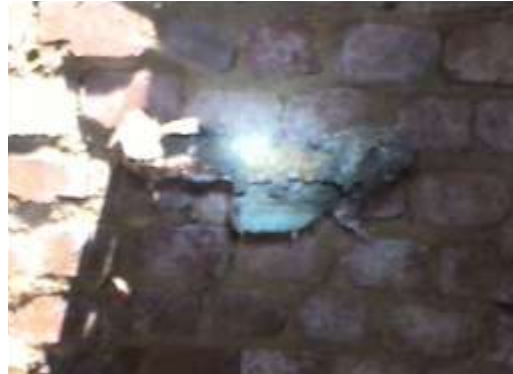
Defect 1

**Steps** Count: **4** Missing: **0** ☒ **Corroded**

**Surcharge** ☒ **Evidence Of Surcharge** Depth: **4** (ft.) ☐ Active Surcharge Present

EVIDENCE OF SURCHARGE/  
CORRODED RUNG

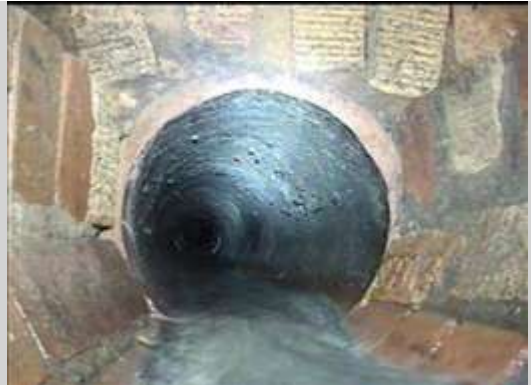
12 O'Clock Outflow

DEBRIS ON BENCH

Pipe Height: (in.) Direct  
Pipe Material: **Clay** ☐ Pipe Lined  
Invert Depth: **8.50** (ft.) Flow Characteristics: **Slow**  
Deposits: ☒ None ☐ Mud ☐ Sludge ☐ Debris ☐ Grease  
Silt Depth: (in.) Deposits Extent:  
Infiltration: **None** Pipe Seal Cond: **Sound**

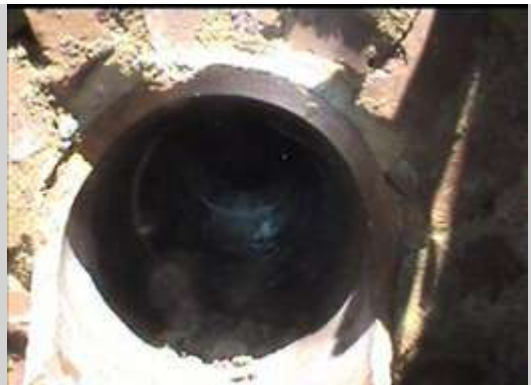
3 O'Clock Inflow

DEBRIS ON BENCH

Pipe Height: (in.) Direct  
Pipe Material: **Clay** ☐ Pipe Lined  
Invert Depth: **5.16** (ft.) Flow Characteristics: **None**  
Deposits: ☐ None ☐ Mud ☐ Sludge ☒ **Debris** ☐ Grease  
Silt Depth: **0.5** (in.) Deposits Extent: **Light**  
Infiltration: **None** Pipe Seal Cond: **Broken**

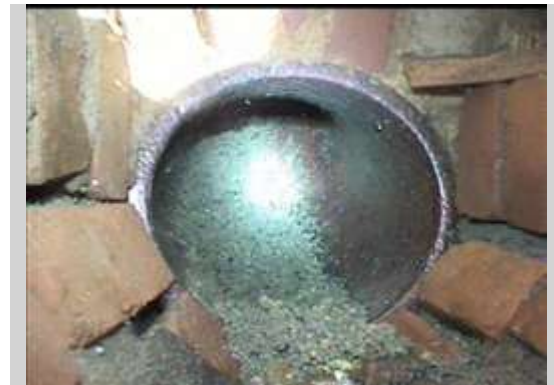
Drop In @ 3 O'Clock

DEBRIS ON BENCH

Drop: **Outside Direct**  
Angled: Reading: (ft.)  
Inv Depth: **8.48** (ft.)  
Drop Condition: **Open**

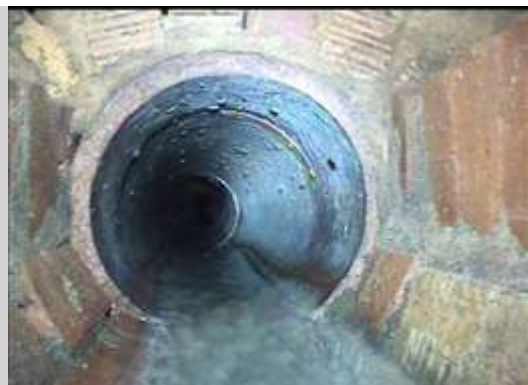
6 O'Clock Inflow

Invert Depth: **8.46** (ft.) Flow Characteristics: **Slow**

Deposits: ☒ None ☐ Mud ☐ Sludge ☐ Debris ☐ Grease

Infiltration: **None** Pipe Seal Cond: **Sound**
